RE: **Analysis of Brownfields Cleanup Alternatives (ABCA), Former Nursing Home (BSAG207), 400 W Grogan Street, Hamilton, Texas 76531.**

# LIMITED ASBESTOS SURVEY REPORT

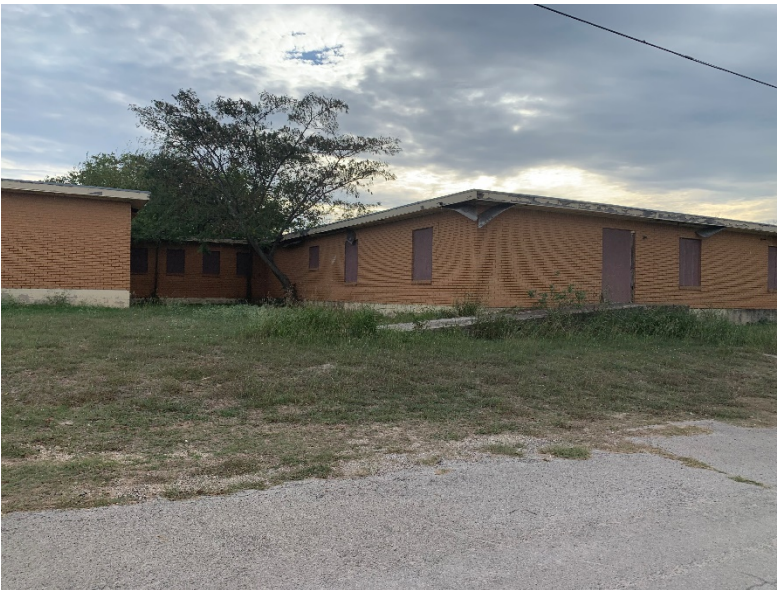
Former Nursing Home Exterior View from W. Grogan St. (Pictured former ADA compliant ramp and connecting hall from main meeting area to housing wards.)

The original building structure was built in approximately 1960. This includes one main meeting area and several connecting housing wards. The property is largely overgrown and only gravel parking areas can be observed. A gravel alleyway is located on the backside of the property and commercial structure. The abandoned nursing home contains several formerly compliant ADA ramps. Please see additional pictures in Appendix I.

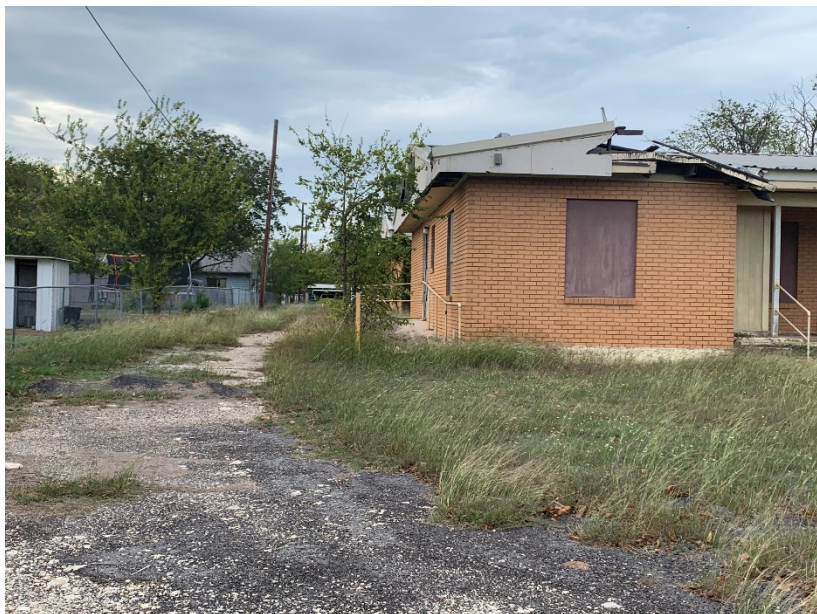
Former Nursing Home Exterior View from S. Stidham St. (Pictured backside of property with gravel alleyway.)

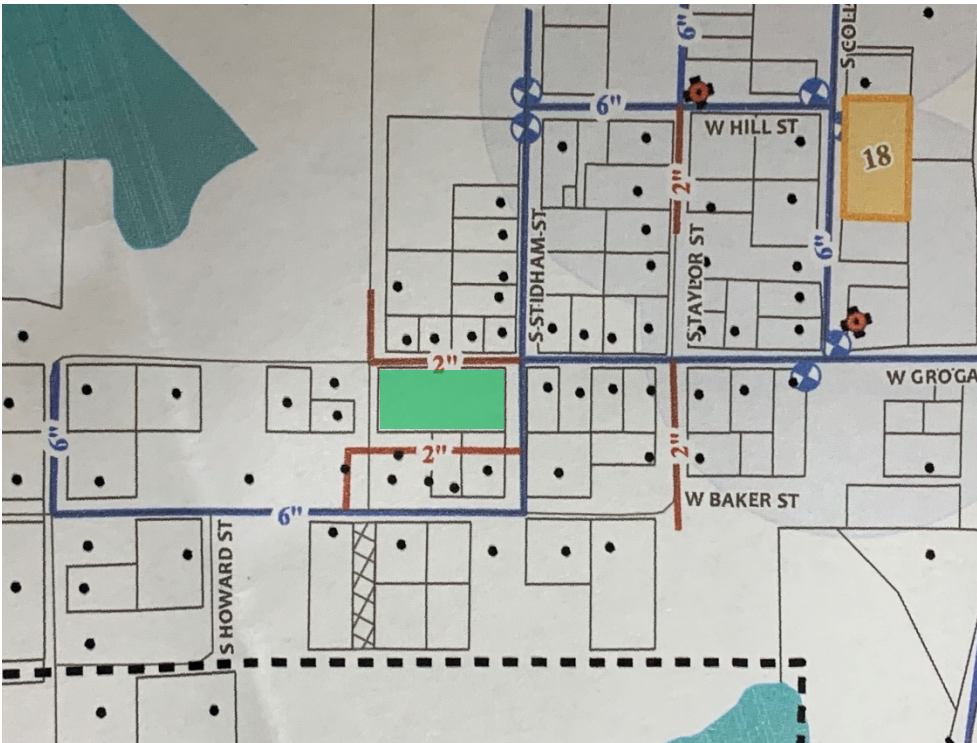
Water utility line map provided by the City of Hamilton  
Former Nursing Home Property bounded in green.

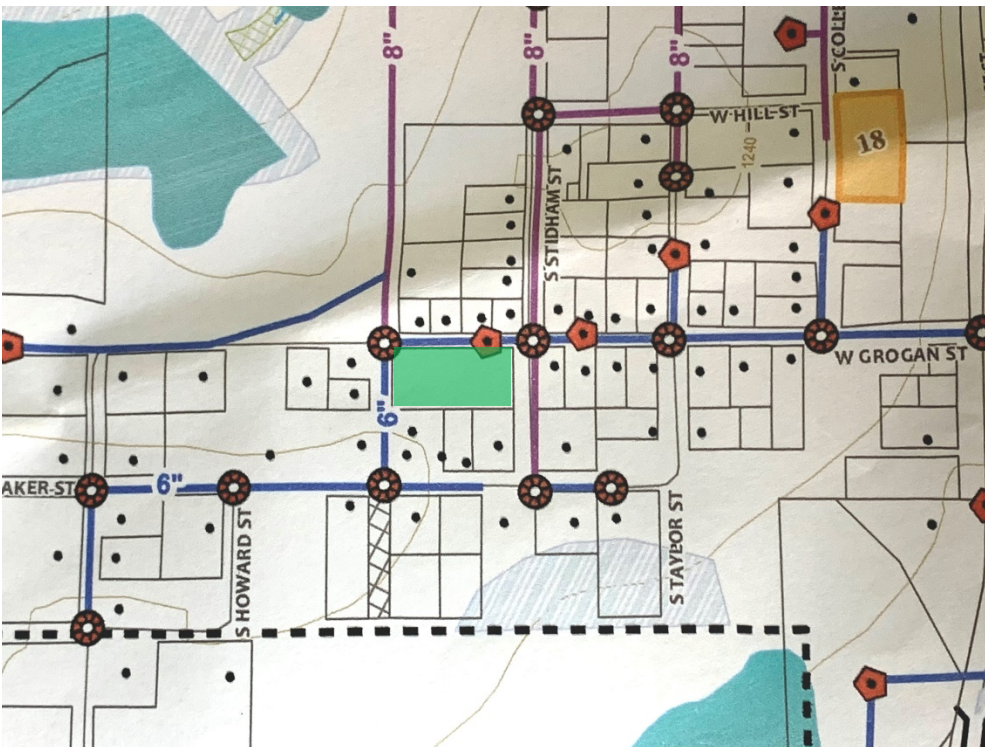
Wastewater utility line map provided by the City of Hamilton  
Former Nursing Home Property bounded in green.
